A320F Engine Pylon Fairing

Engine Pylon Fairing (414FR/423FL)

Acetek's Repair Service

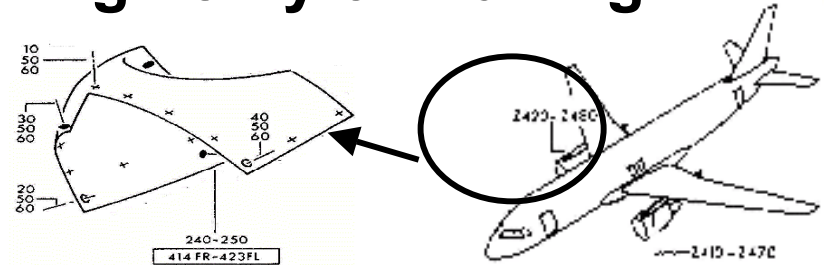
Pylon Fairings are contoured secondary structures; sandwich panel with a monolithic panel edge section, enclosing the engine attachment pylon.
