A320F Flap Track Fairing

Flap Track Fairing

Acetek's Repair Service

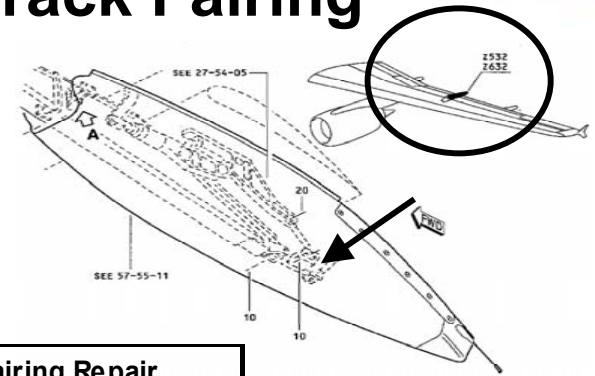
The Flap Track Fairing is a canoe shaped structure that rests under the wing and encloses the wing flap deployment mechanism.

- OEM supplied composite materials in a Flap Track Fairing are:
 - 1/8", 4.0 lb hexagonal Nomex honeycomb core
 - 250°F/121.11°C cure, 5H satin weave carbon fiber prepreg, 45% resin
